**DENDROCHRONOLOGICAL STUDY OF THE
HAMMERSTONE AND GALLOWAY BARN
HOLLAND TOWNSHIP, NJ**

**Prepared by:
Richard Veit, Ph.D.
2317 Linden Ave.
South Plainfield, NJ 07080**

**Prepared for:
Holland Township Historic Preservation Commission
Holland Township, NJ**

February 5, 2012

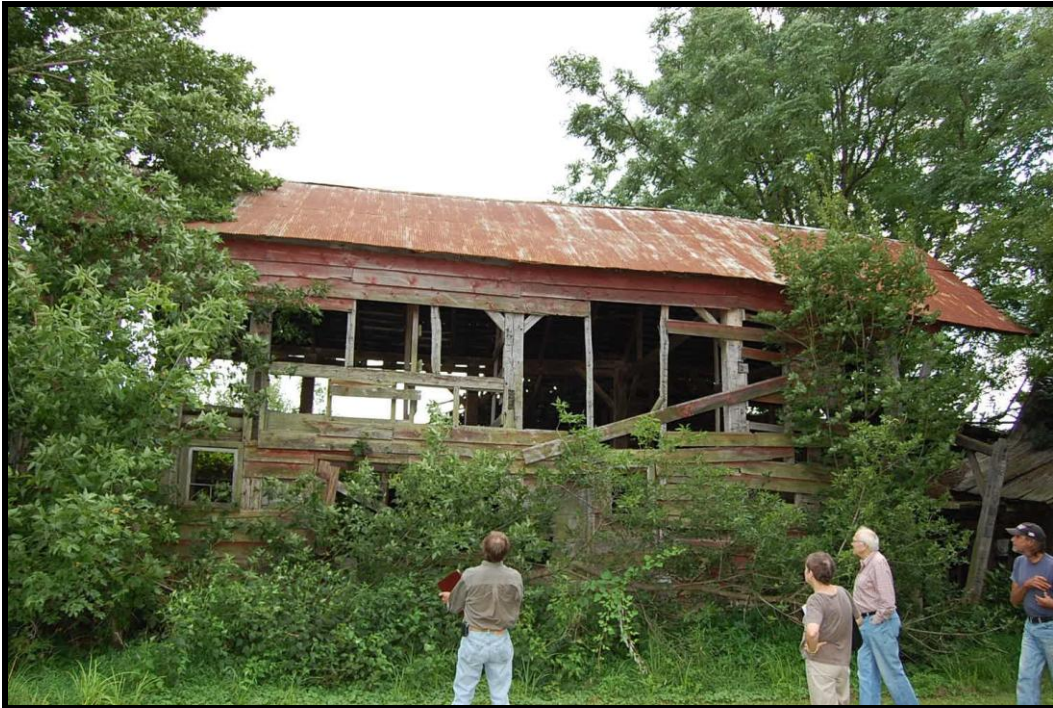
Figure 3. A more recent photograph of the Galloway Barn prior to dismantling.
